AVIATION INVESTIGATION REPORT
A00P0210

LOSS OF POWER AND COLLISION WITH WATER

WEST COAST AIR
de HAVILLAND DHC-6 (TWIN OTTER) C-GGAW
VANCOUVER HARBOUR, BRITISH COLUMBIA
01 NOVEMBER 2000

Report Number A00P0210

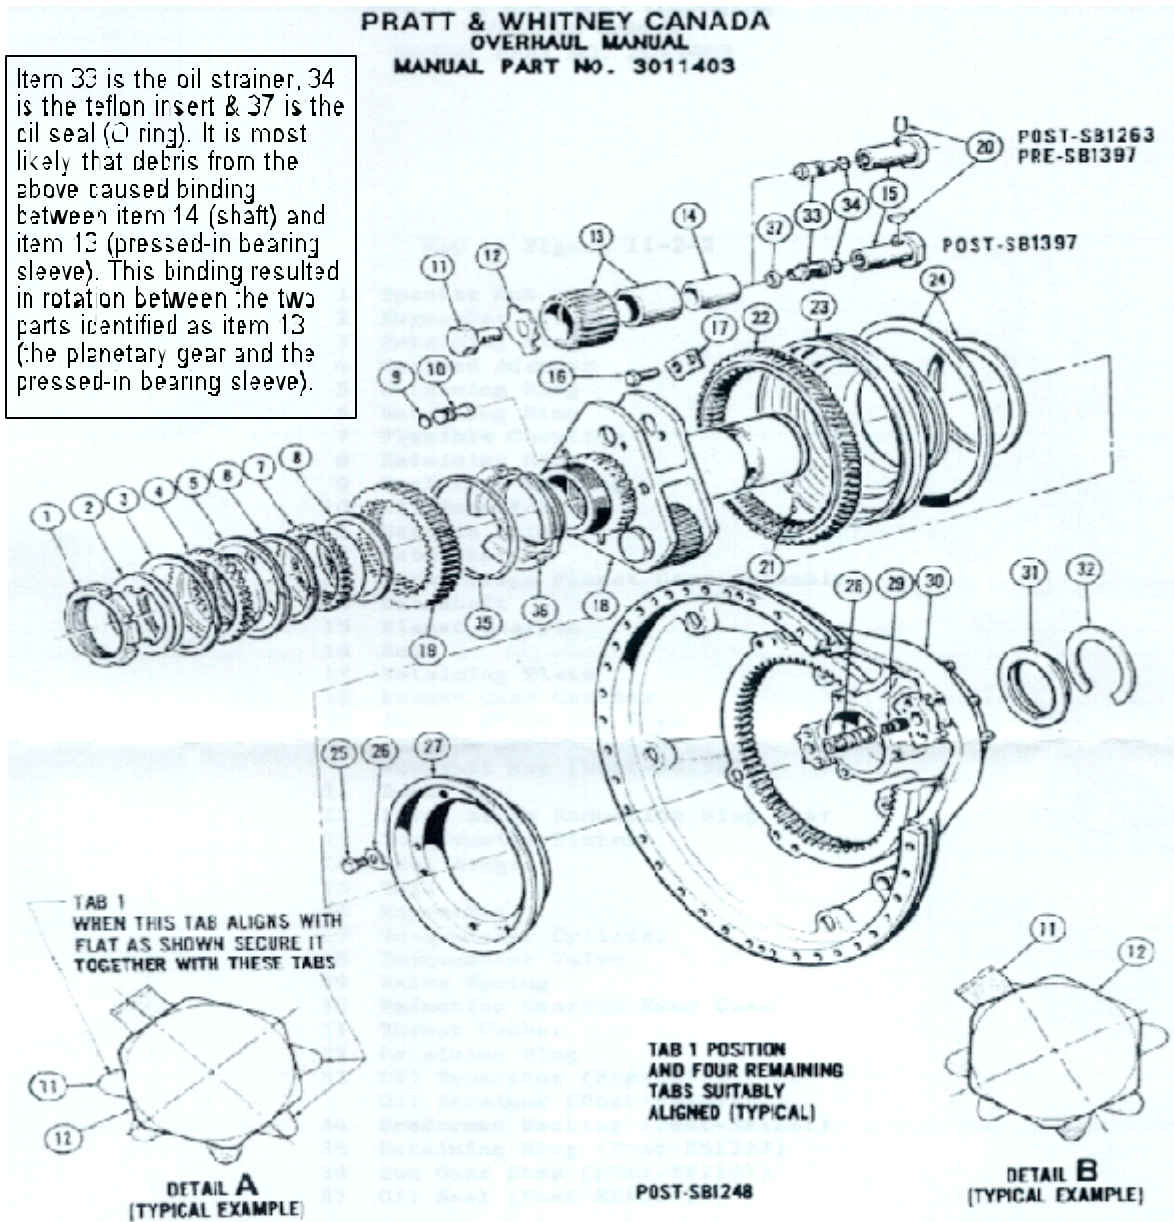
Figure 11-2-2 Reduction Gearbox Rear Case Assembly (Post-SB1124 and all PT5A-20A Engines)

The planet gear oil strainer screen exhibited a deformed Teflon insert, pinched "O" ring, bent "neck" and fretting of the strainer housing suggesting an improper installation of the strainer within the pin. The screen beneath the outer screen exhibited fractures in the braze and wires. The wires fractured by fatigue. Some wire fracture surfaces were smeared and corroded suggesting the fractures were not recent, and as a result, the fracture of the strainer is believed to be a consequence of the installation. The release of wire fragments and debris may have subsequently initiated or contributed to the distress of the bearing sleeve.

1. A planetary gear disintegrated in the propeller reduction gearbox of the No. 2 engine and caused the engine drive shaft to disconnect from the propeller, resulting in a loss of propulsion from this engine.
2. The planetary gear oil strainer screen wires fractured by fatigue as a consequence of the installation at the last overhaul. This created an unsafe condition and it is most probable that the release of wire fragments and debris from this strainer screen subsequently initiated or contributed to distress of the planetary gear bearing sleeve and resulted in the disintegration of the planetary gear.

Item 33 is the oil strainer, 34 is the teflon insert & 37 is the oil seal (O ring). It is most likely that debris from the above caused binding between item 14 (shaft) and item 13 (pressed-in bearing sleeve). This binding resulted in rotation between the two parts identified as item 13 (the planetary gear and the pressed-in bearing sleeve).

Pratt & Whitney Canada has confirmed that the Overhaul Manual applicable to the P&WC PT6-20 series engine RGB was revised in 1998 to clarify the installation procedure of the planetary gear oil strainer screens.
